Superfund Five-Year Review Report

Davie Landfill

Davie, Broward County, Florida

Prepared for
U.S. Environmental Protection Agency, Region IV
May 2000

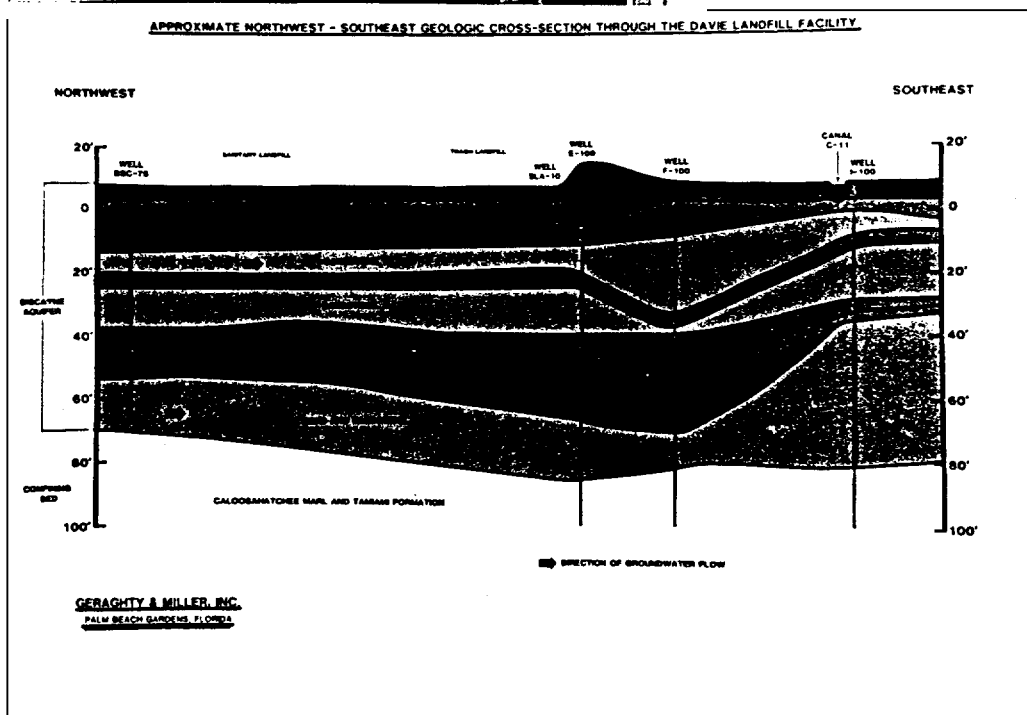
FIGURE 3

Figure 3: General Groundwater Movement of Site, From Final Report Broward County Landfill, Camp Dresser & McKee Inc. (January, 1983)

Plan view illustrates the general groundwater movement on the site. The geological cross-section shows the various aquifers which groundwater moves at the 20, 50 and 60 foot depths.

A. While not required under the ROD, UAO or FDEP closure permit - GW contour maps are not included in the GW semiannual reports. It may be useful in the future to include the maps to better understand the GW flow patterns at various depths of the aquifer and to determine if any GW flow anomalies not noted in the past exist.

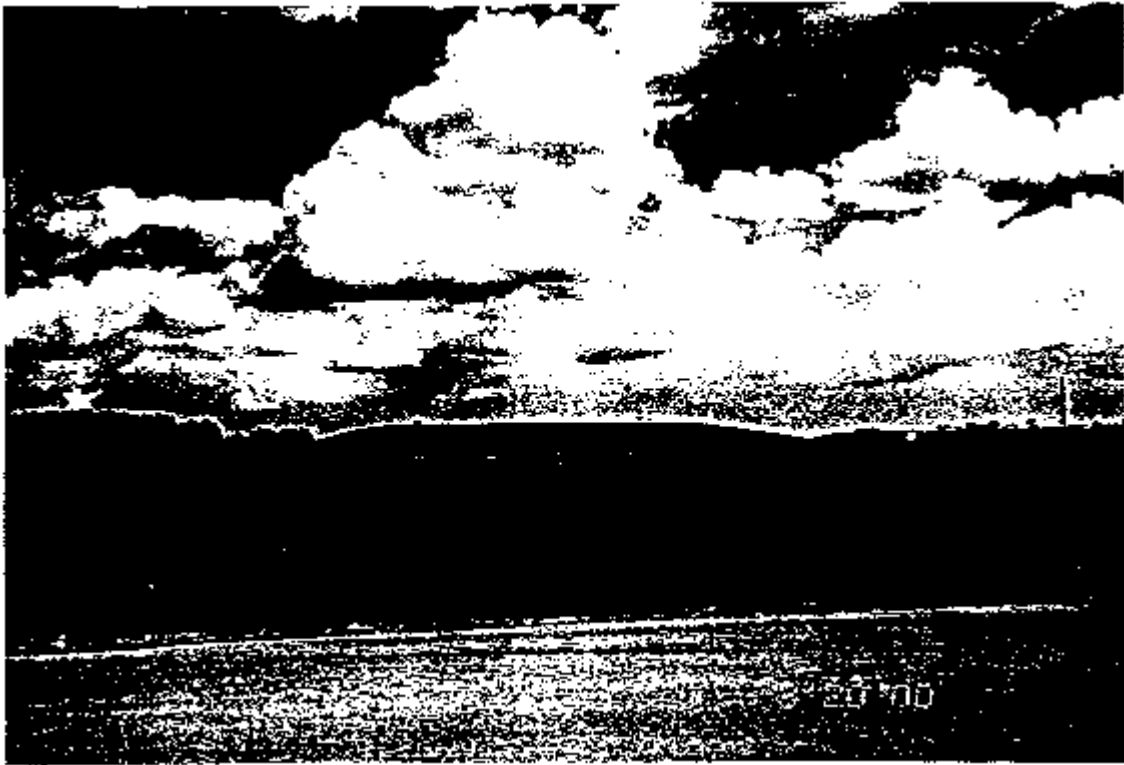
Photograph #1

Description: View of DLS behind bordering Dairy Farm. The Northmound is to the left and the Southmound is to the right [*facing east, from shotgun rd.*].

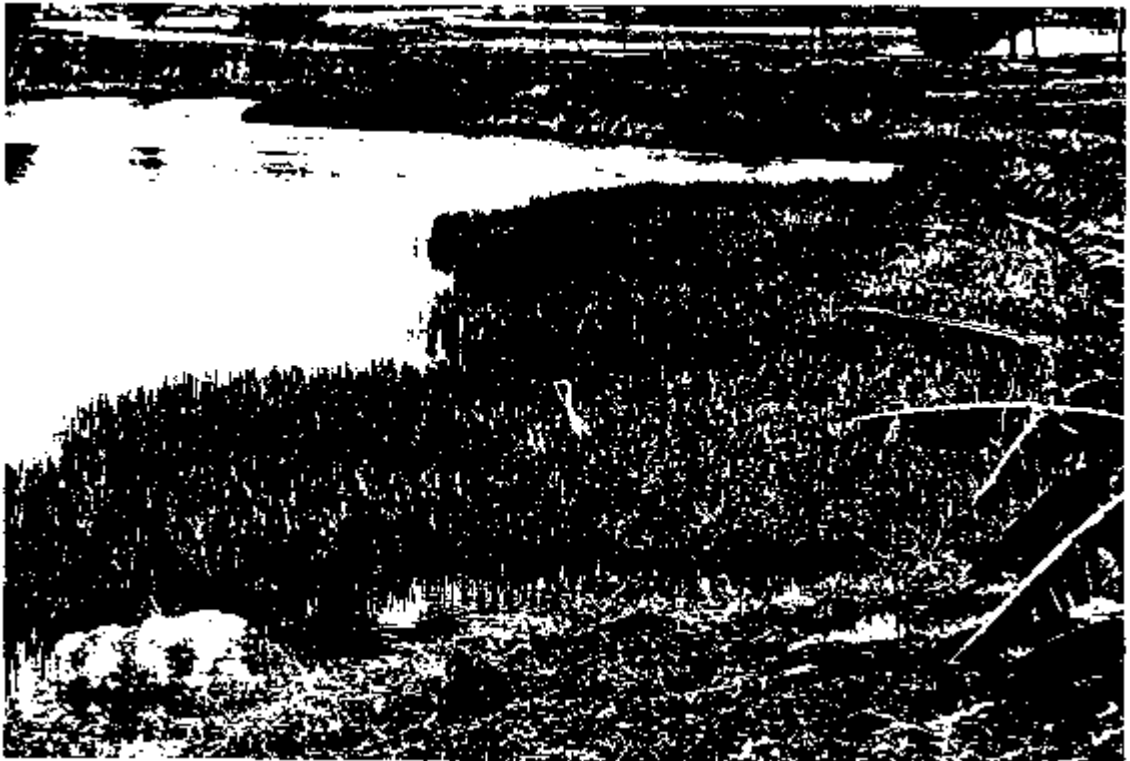
Photograph #2

Site Drainage Features. Surface water runoff collects in a series of three lakes, the pond and retention perimeter berms. Lake numbers 1, 2, and 3 all appear to be in good condition. The former sludge lagoon as noted in the first five-year review is still a thriving nature pond. The spillway channel from Lake 2 to Lake 3 was free of obstructions and appeared to be working as designed. The berms appeared to be in good condition. The sand trap was clean and in good condition. The site drainage culvert leading to the offsite ditch was also clean, free of debris and in good condition. Several Bass fish were observed in lakes 1 and 2.

Description: Nature pond (former Sluge lagoon) shows Egret and Ducks: [*facing northeast*].

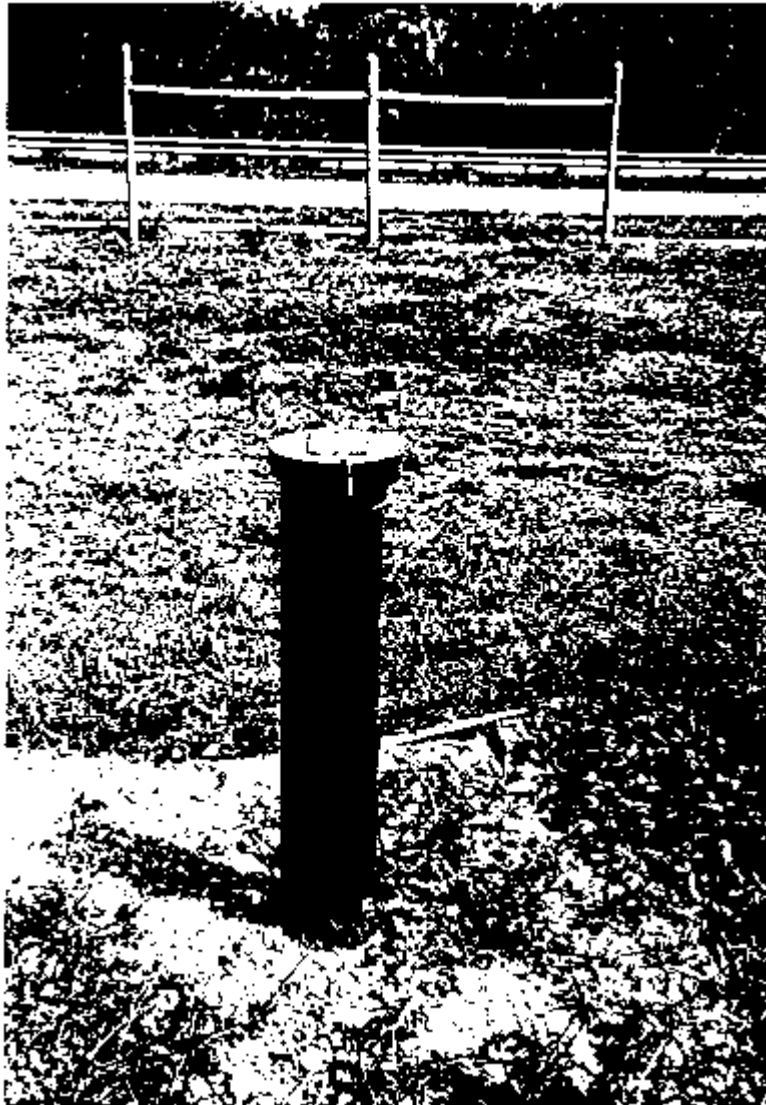
Photograph #3

Description: Close up of MW in cluster #8 shows locked protector casing: [*facing east, from east property boundary*].

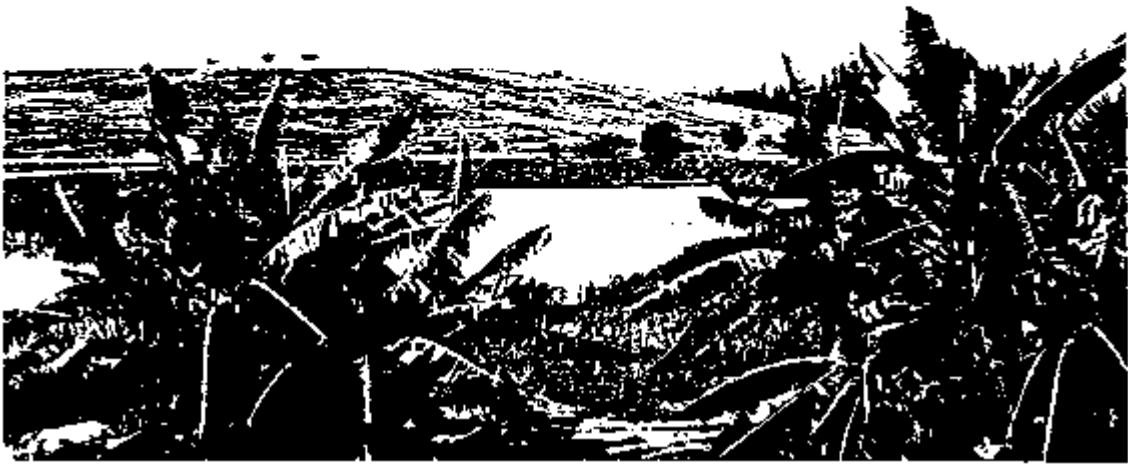
Photograph #4

Description: View of nature pond with northmound in background: *[facing northeast, from road]*.

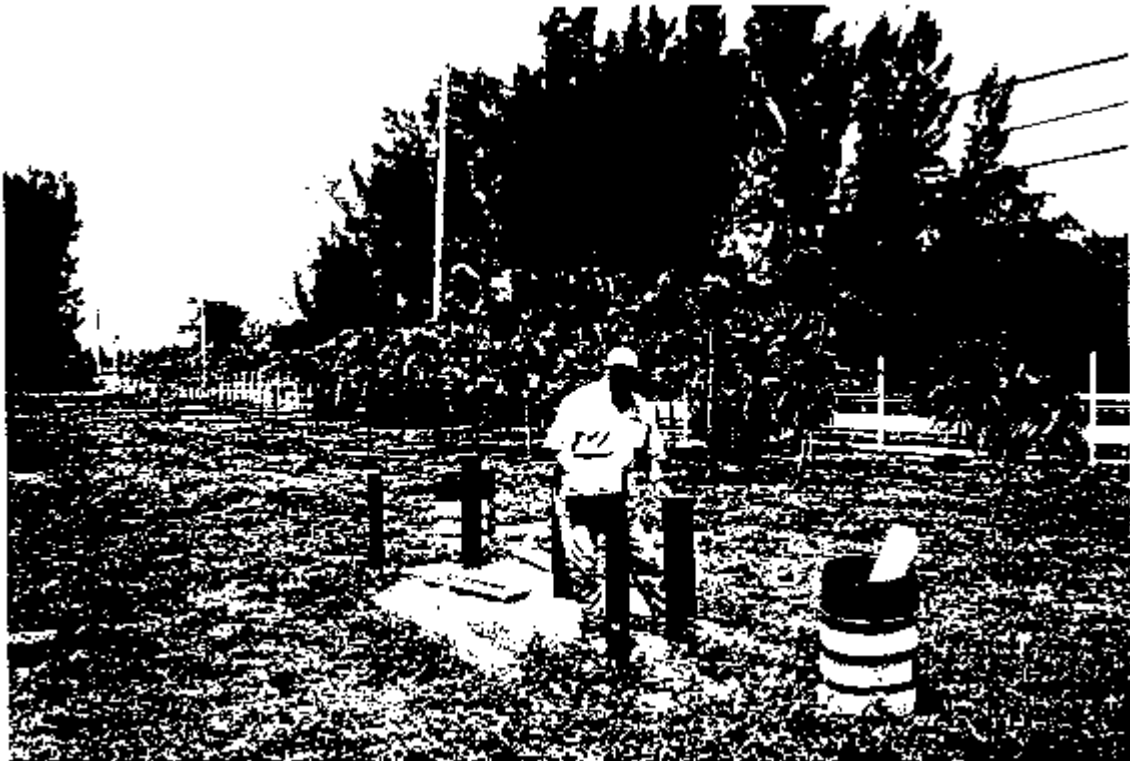
Photograph #5

Monitoring Wells. The monitoring wells observed appeared to be well identified and in good condition. The locks were also in good shape. MW cluster #11 is located on a sand rim and showed signs of settlement including cracked concrete around the base of the wells. Presently this does not affect the structure and integrity of the wells. However it should be monitored for any long-term change in condition.

Description: MW cluster #8, MWs are in good condition, clearly identified and are easily accessible: *[facing northeast, from cluster #8 next to Boy Scout Rd.]*.

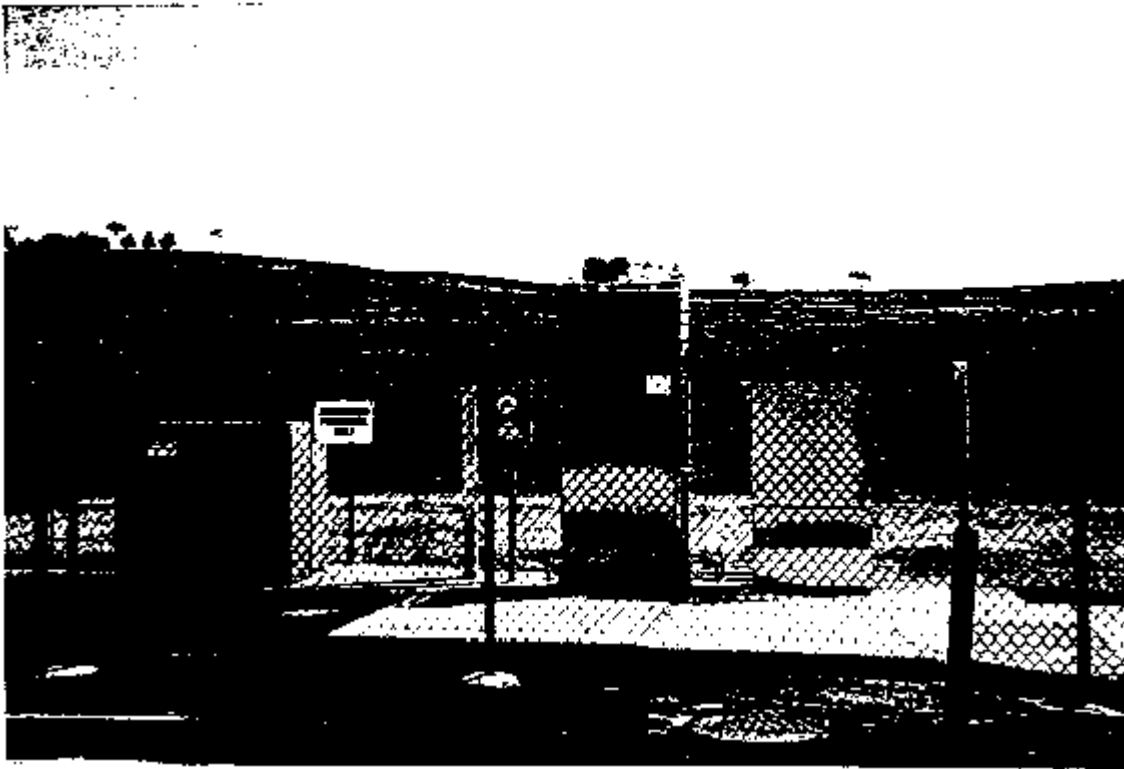
Photograph #6

Description: Main Leachate Sump Station with control panels: *[facing south, southmound in background]*.

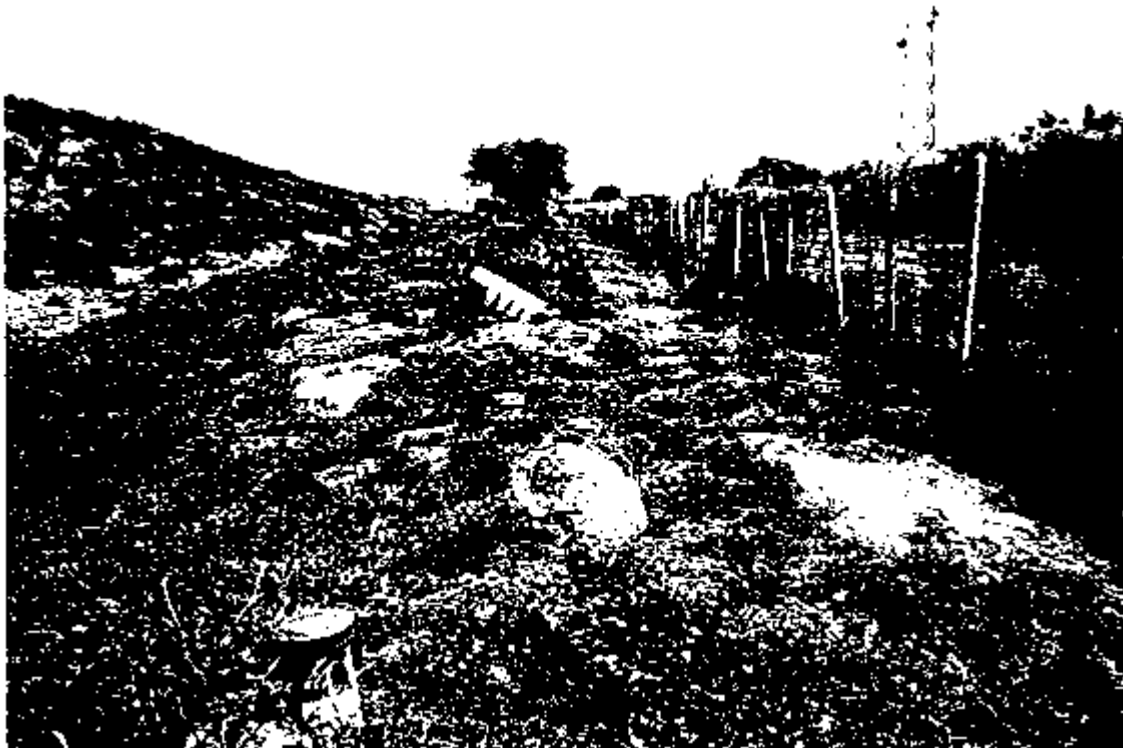
Photograph #7

B. Some settlement has occurred in the area, although this is not a short term problem, if not monitored properly it could develop into a long term one (IE. damage to Gas Recovery Wells, Leachate Lines, Monitoring Wells).

Description: MW cluster # 11, shows some settlement along berm: *[facing east, along southern border]*.

B. Continue to monitor for any settlement changes (i.e. berms and landfill covers) and make adjustments or repairs as necessary in order to compensate.

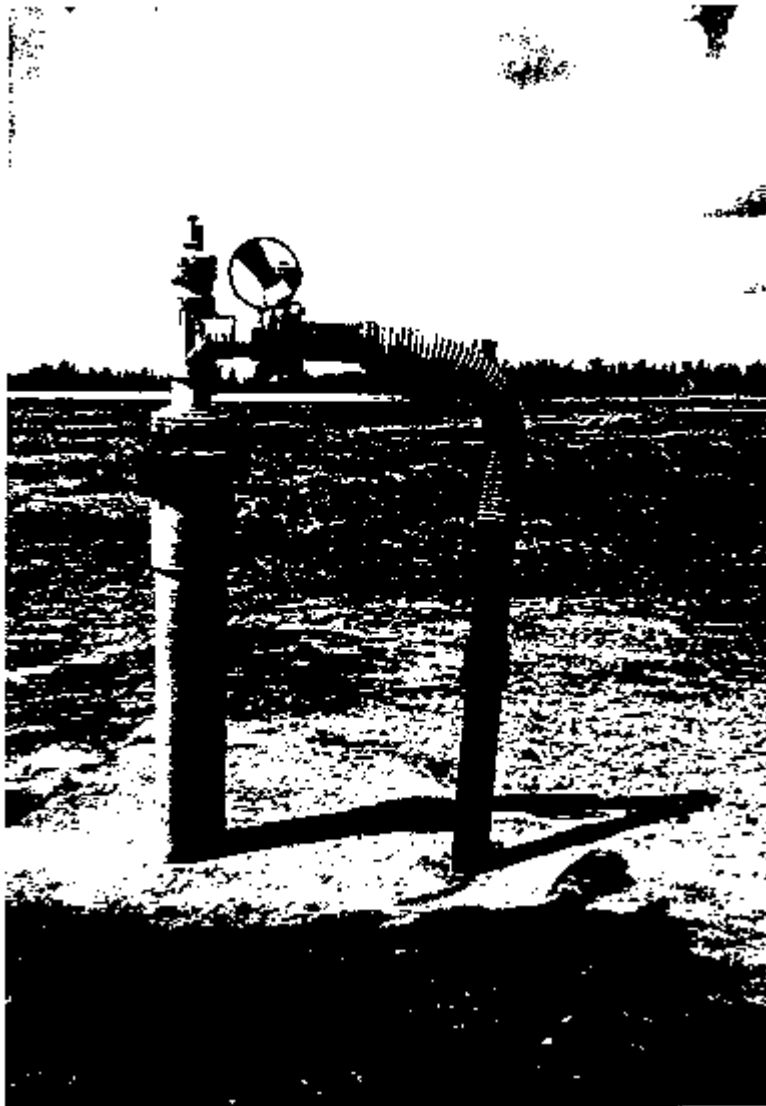
Photograph #8

Landfill Gas Control System. Several gas extraction wells were observed on the North Mound of the DLS. Some settlement has occurred in the area but appears to have not impacted the condition and operating efficiency of the wells. Presently, this is a long term impact situation that Broward County is aware of and continues to monitor. The Active Gas Flare System was observed to be locked and secure. The DLS gas collection system appears to be functioning adequately at this time. The Flare is currently run on a timer where it burns off landfill gas for six hours on and six hours off. Adjustments to the system can be made as needed, depending on the quantity and quality of landfill gases.

Description: Close up of landfill gas extraction well on North Mound: *[facing north, from top of mound]*.

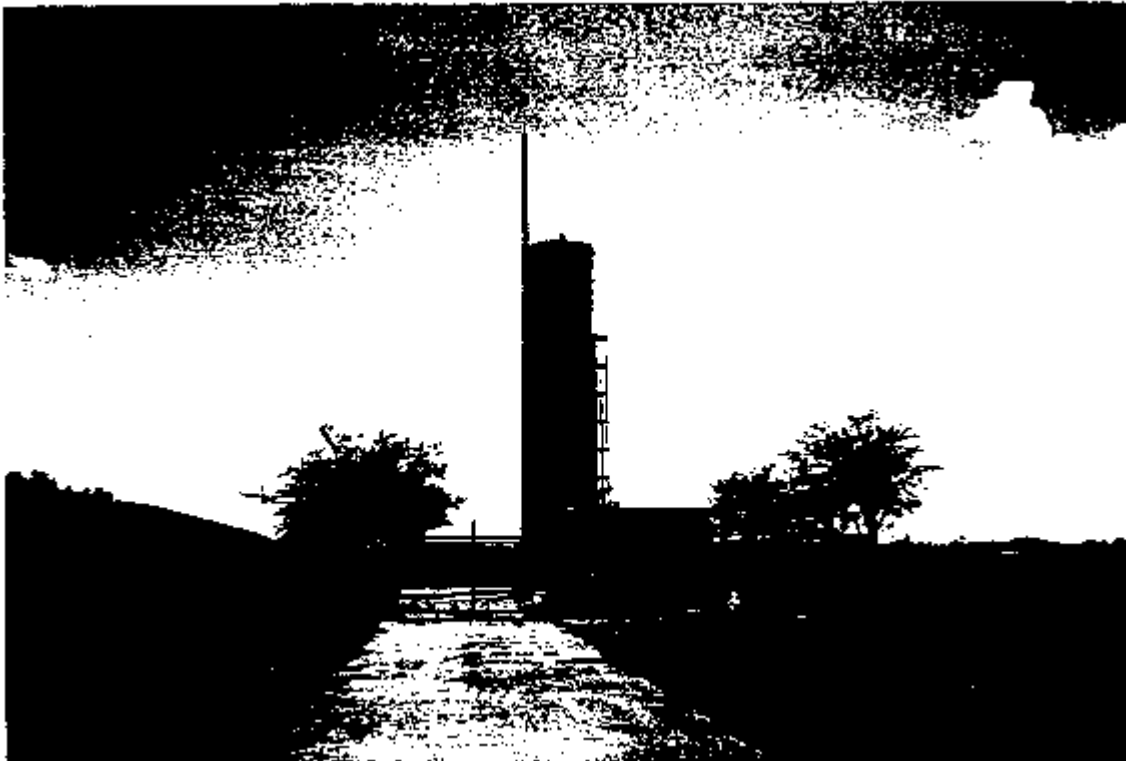
Photograph #9

Description: The DLS flare system; locked and secure: *[facing south, along western border]*.
